Lee County Inspection Services Home Inspections

Brooks, John. (09.20.19 HI3118)
5232 SW 2nd Ave
Cape Coral, FL 33914
Phone: 239.246.9534

ID: 09.20.19 HI3118
5232 SW 2nd Ave
Cape Coral, FL 33914

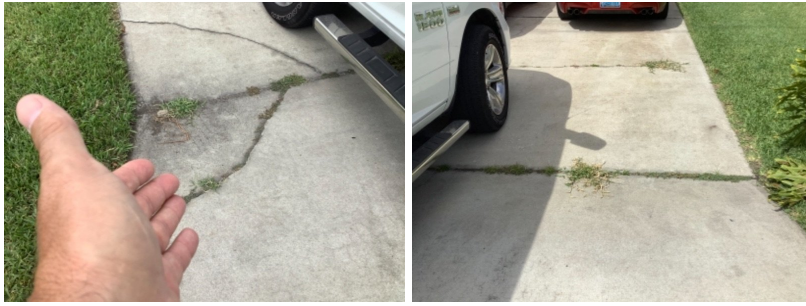
Concrete driveway has minor cracking, normal settlement, monitor for expansion and future condition. 2- Separation cracks noted, see photo. Monitor for future condition or development of a trip hazard.

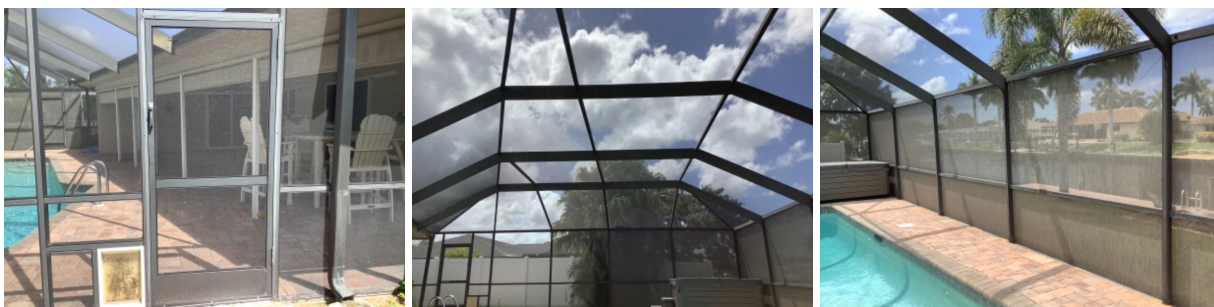
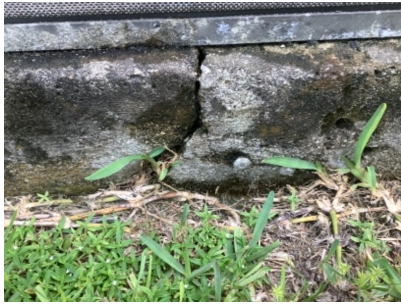
Paver patio deck appears sound and free from substantial visual defects. Aluminum screen enclosure appears sound and free from visual defects unless otherwise noted. 2- Several bottom rail fasteners of screen enclosure are corroded or missing. 3- Screen doors need minor adjustments to sweep and spring stop mechanism, not operating as intended. 4- Expansion crack noted to rear of paver foundation, see photo.

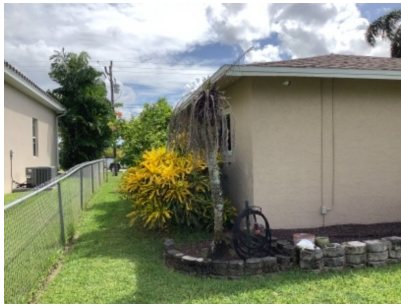
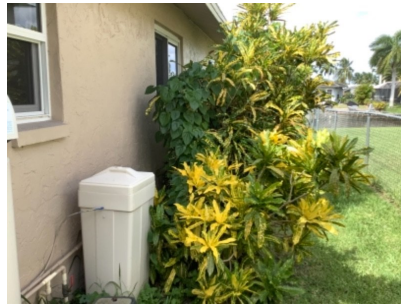
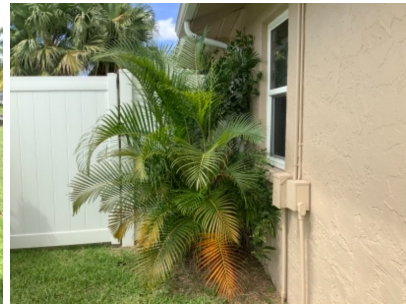
Monitor root systems near foundation. 2- Trees and tree roots should be trimmed back away from foundation, exterior walls and rooflines.

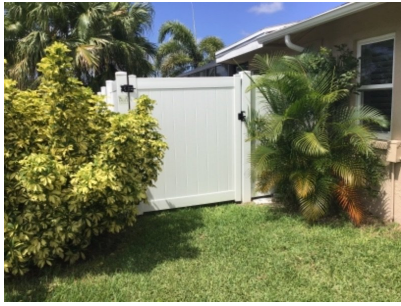
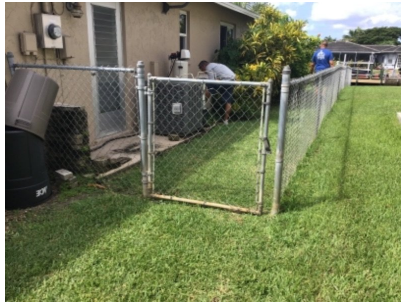
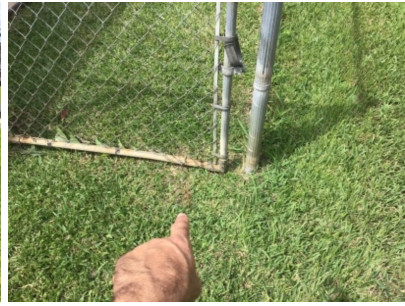
Vinyl fencing left side of property appears sound and freed from substantial visual defects. 2- Chain-link fencing on right side of property appears sound and free from substantial visual defects. Chain-link gate entrance needs repair, gate is sitting on ground level.

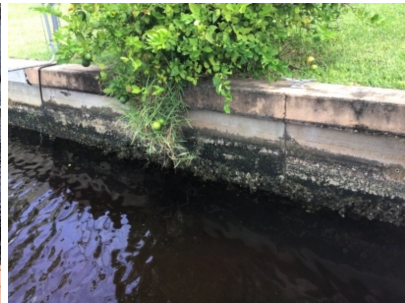
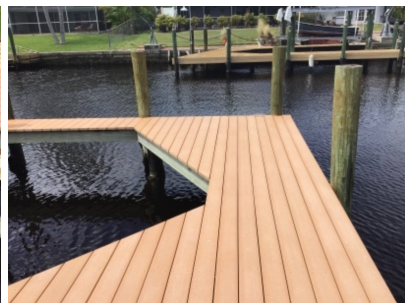
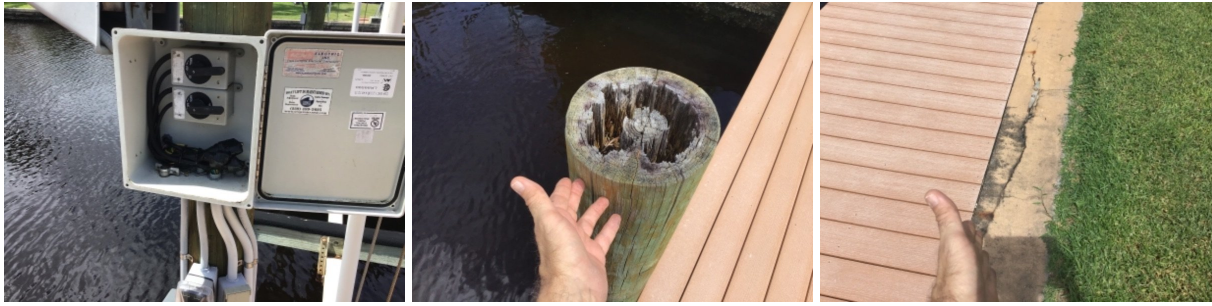
Bulkhead/ sea wall inspected from ground level only, appears sound and free from substantial visual defects. Seawall has expansion cracking in select areas. 2- Composite deck and dockage appears sound and free from substantial visual defects. 3- Wood pier system appears sound, select pier appears to have wood rot at top, see photo. 4- Boat lift appears in operating condition and free from visual defects. Boathouse, Dock & Shoreline permitted 09/25/2012.

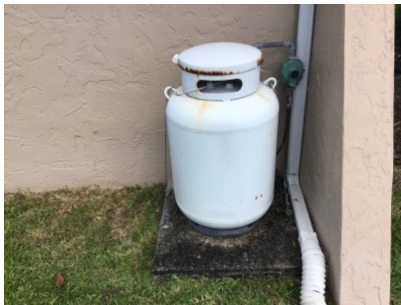
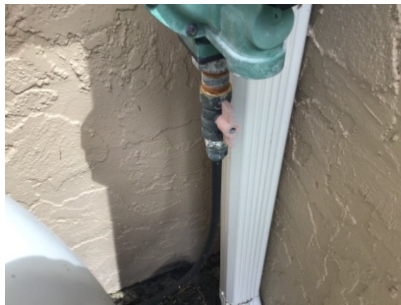
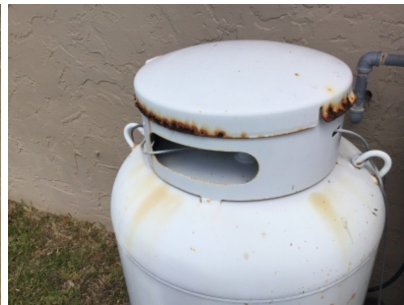
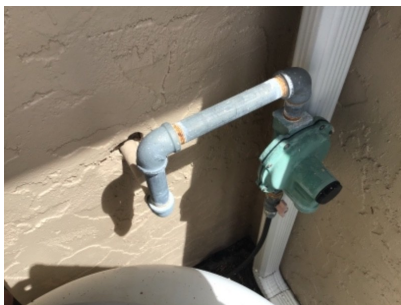
Gas system and its components appear sound and free from visual defects. Limited inspection, recommend further consultation by identified supplier for operation and maintenance of the system. 2- Supply tank has exterior rusting to same, see photo.

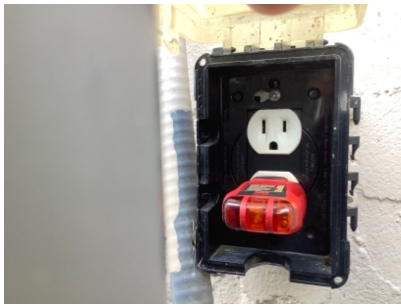
All exterior GFI outlets are functional unless otherwise noted. 2- Exterior outlet on right side wall is functional but not tripping, may not be GFCI rated.

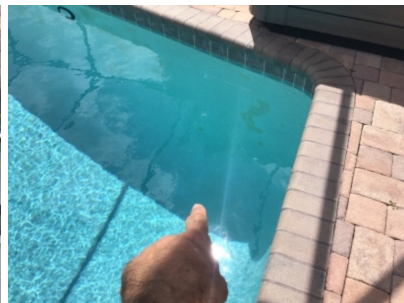
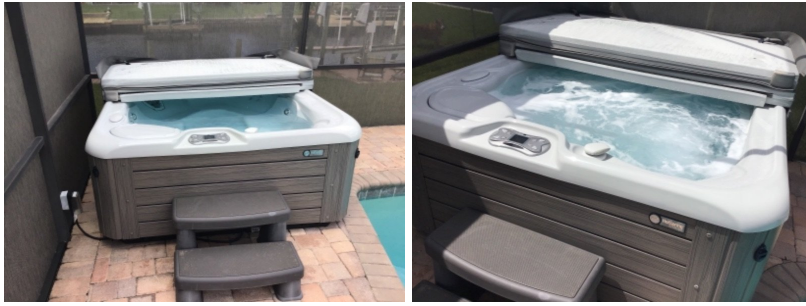
Pool & Spa permitted 10/31/1997. Pool system appears structurally sound. Limited inspection of concrete liner due to water fill. Staining noted to liner throughout system. 2- Cartridge filter appears in operating condition and free from visual defects. 3- Electric pump appears in operating condition but unit is covered with rust. 4- Pool light appears in operating condition. 5- There is no baby barrier fencing or interior door alarms for child safety. 6- Portable spa package appears in operating condition free from visual defects. Recommend further review and the necessary maintenance/updates or repair by a licensed contractor.

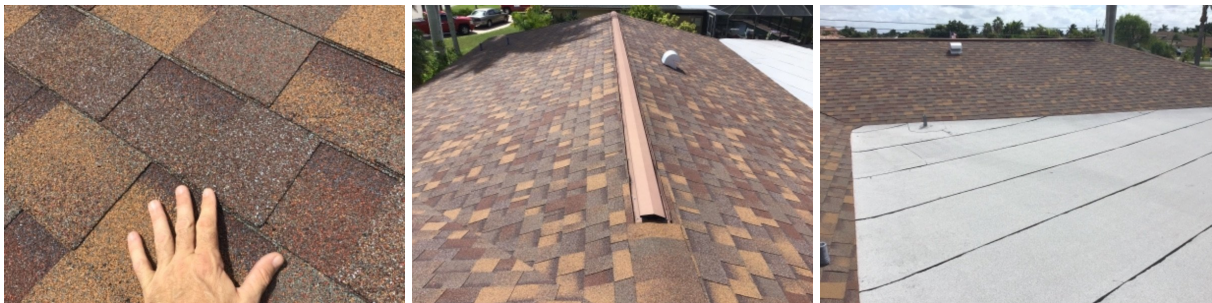
Architectural asphalt fiberglass shingles appear sound and free from visual defects. Average lifespan of architectural asphalt shingle in SW Florida is 20-25 years. Roof permitted 03/04/2016. 2- Flat asphalt roll roof covering appears sound and free from visual defects.

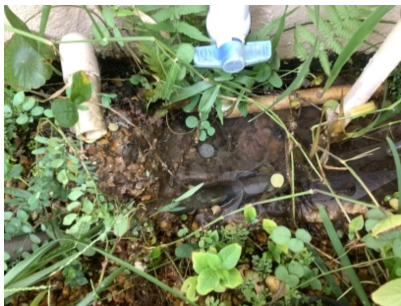
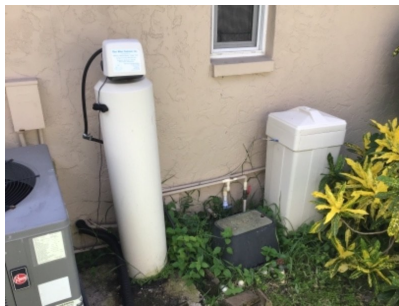
Public water system engaged into home. All components appear to be engaged, functional and free from leakage unless otherwise noted. Water treatment components present. 2- Pooling water below main shut off valve, piping appears unsecured. Recommend further review of this condition.

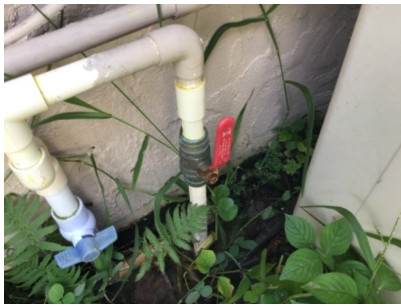
Water entrance valve and line appear sound and free from visual defects. 2- Secondary valve for plumbing fixtures on dock engaged and appears sound and free from visual defects.

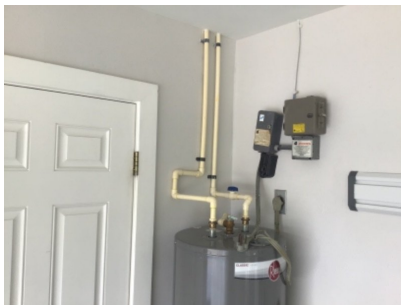
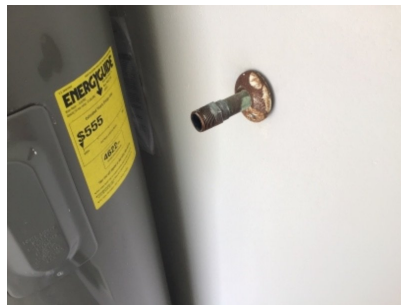
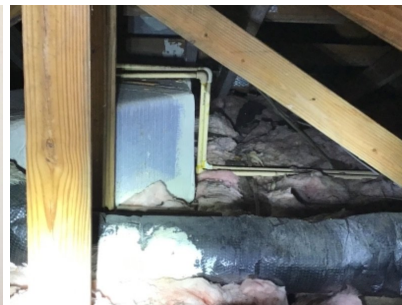
CPVC supply plumbing/ piping appears sound and free from visual defects. Copper supply appears to have been disconnected. Limited views of system in attic. Plumbing Re-Pipe permitted 12/28/1998.

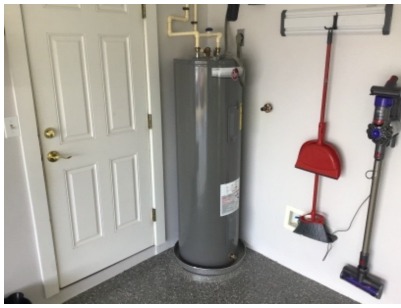
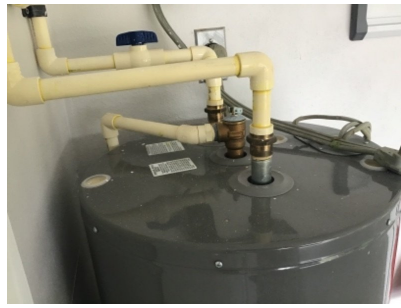
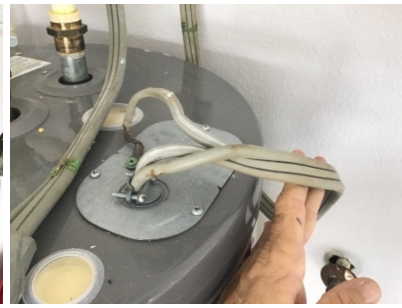
Water heater appears sound and free from visual defects unless otherwise noted. 2- Recommend flush out of unit on an annual basis as regular maintenance. Recommend test check on TPR valve on an annual basis for proper functionality. Make: Rheem. Year: 2016. 3- Electrical service into unit is not enclosed in protective conduit. There is an additional power box and cord that is not being used, see photo.

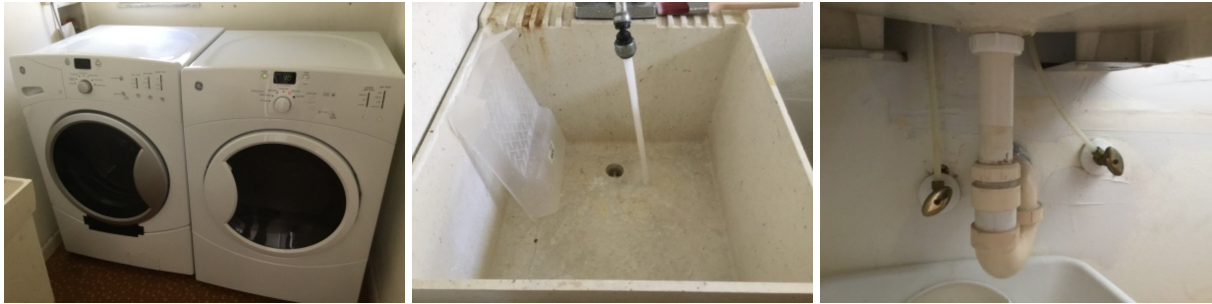
GE washer and dryer appear in operating condition and free from visual defects. 2- Recommend dryer vent cleaning upon purchase and on an annual basis. 3- Slop sink and components appear sound and free

from visual defects. 4- Laundry room receptacle is functional but not GFCI rated. Recommend upgrade to same. 5- Dryer vent cover on outside of building appears damaged.

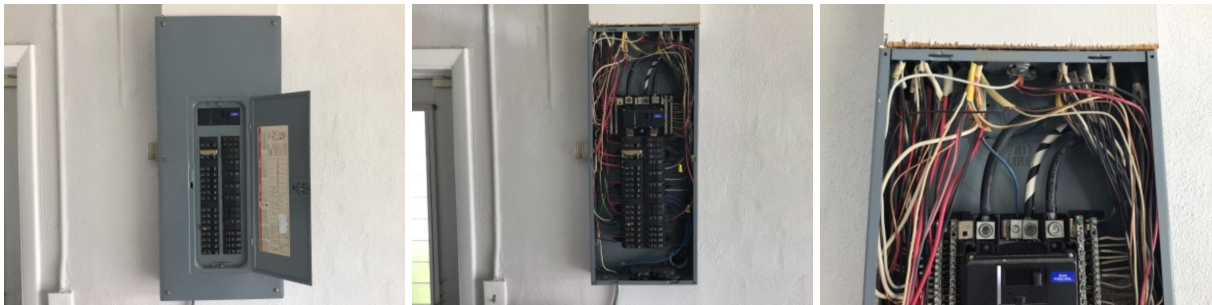
Main electrical panel appears sound and free from visual defects unless otherwise noted. Make: Square D.
2- Circuit breakers for air conditioner appear to arc when turning on and off. Unit shut down halfway through inspection. Recommend further review and the needed repair by a licensed contractor.

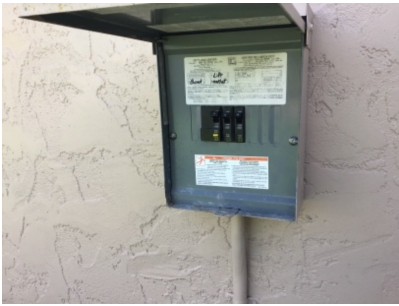
Sub panel on rear exterior wall for dockage electrical supply appears sound and free from visual defects.
Make: Square D.

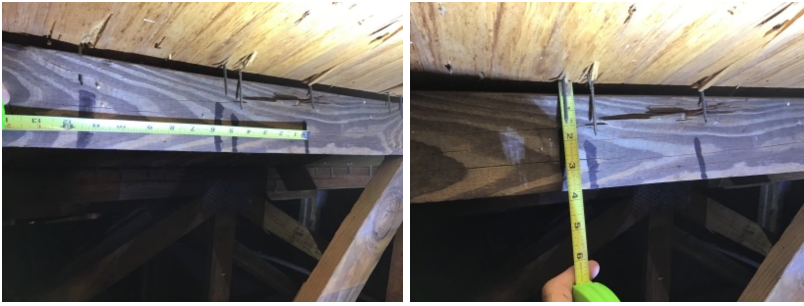
Sheathing appears sound and free from visual defects, most areas have limited views and are inaccessible. Deck fasteners 8D nails spaced every six inches.

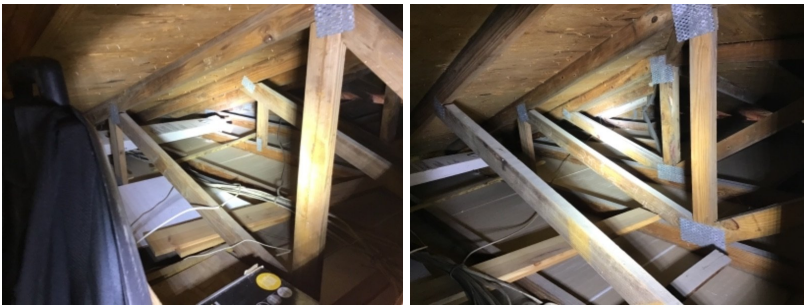
Metal clip (2 nails) roof to wall attachments appear sound and free from visual defects. Ceiling frame appears sound and free from visual defects, limited views.

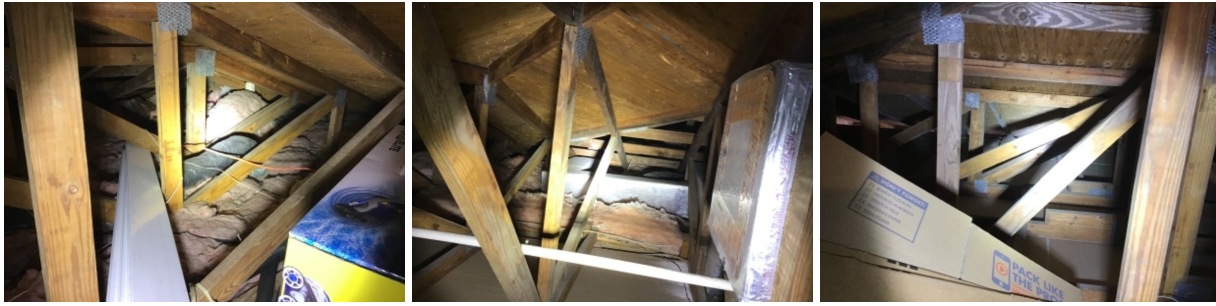
Roof frame and truss system appear to be spanned properly and in sound condition, limited views.

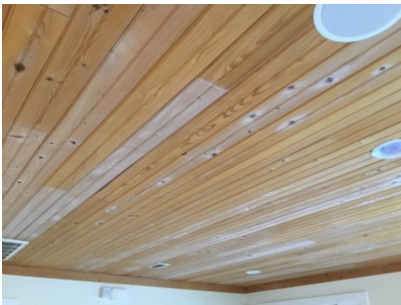
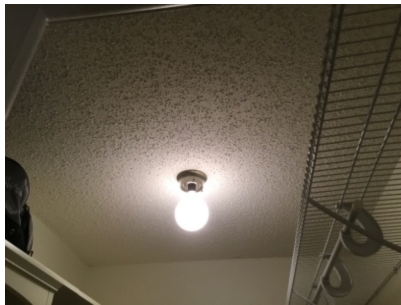
Ceilings appear sound and free from visual defects unless otherwise noted. 2- Wood panel ceilings possibly over popcorn ceiling.

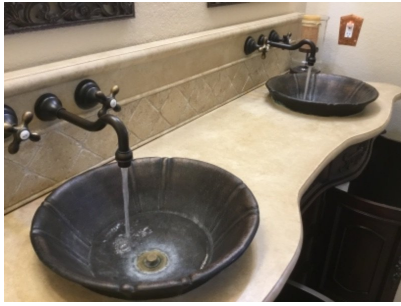
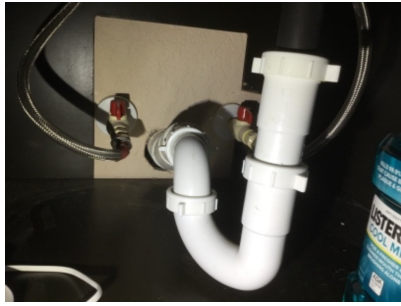
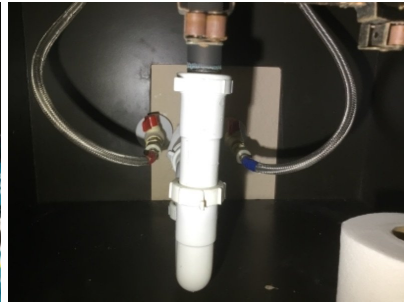
Sink appears sound and free from visual defects unless otherwise noted. 2- There is no overflow protection drain for water in sinks.

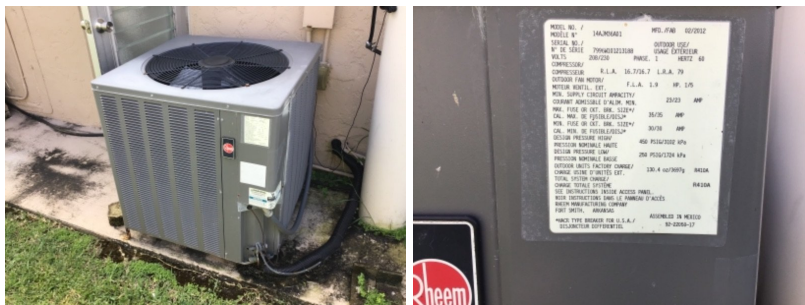
Exterior condenser unit appears sound and free from visual defects unless otherwise noted. Average lifespan for this unit is 15 years. Make: Rheem. Year: 2012. 2- This unit shut down halfway through inspection, appears to be electrical deficiency.

AC New / Change Out permitted 05/31/2012.

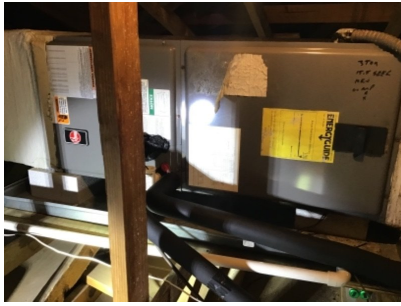
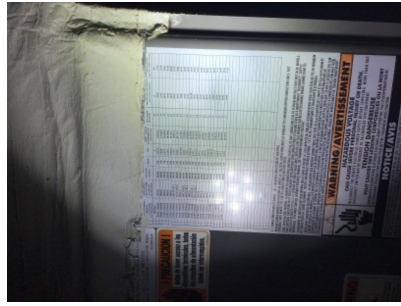
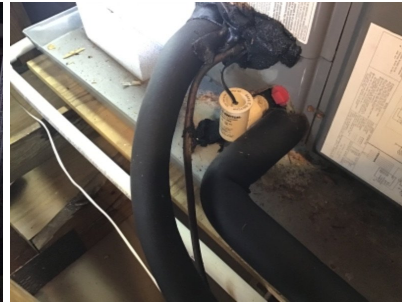
Air handler, located in attic space above garage, appears sound and free from visual defects unless otherwise noted. Heat tested and functional as well. 2- Recommend changing/ cleaning filters in system on a regular basis, every 30-60 days. System repairs previously noted. Make: Rheem. 3- Limited views of ductwork.
